GORBEL TETHER TRACK FALL PROTECTION SYSTEM AT RV CENTER

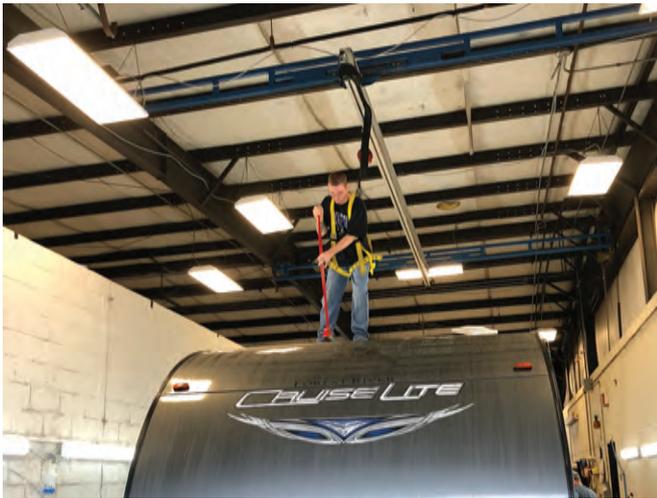
Keep employees safe when performing service or cleaning the top of RVs:

Consisting primarily of fiberglass or rubber exteriors, the surface of an RV becomes extremely slippery when wet. Newer model year RV rooflines are more sloped than older styles, adding a second degree of danger when it comes to working on top of the vehicles. In addition, OSHA requires fall protection for work that is performed at heights of 4' or higher. By utilizing Gorbels tether track system and safety harnesses, workers are securely anchored in place, allowing them to safely perform their job. The new tether track system has a span of 20', allowing workers to easily navigate the entire length of an RV.

As a commitment to keeping employees safe on the job, Keystone RV asked YorkHoist to install a tether track fall protection system and harnesses to their main RV cleaning bay and safety netting over the RV service pit. Technicians from YorkHoist installed a Gorbel single aluminum bridge and steel runway with a 20' span, along with one tether track trolley in the RV cleaning bay. In the RV service bay, they installed 140 square feet of retractable FallProof netting.

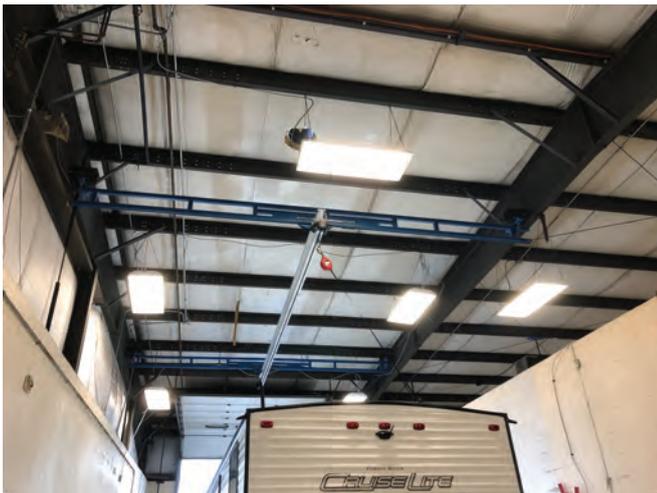
Increase Worker's Confidence:

Some members of the Keystone RV staff were not comfortable working on top of the vehicles, including some RVs with a height of 13' or more. The new safety harnesses and tether track system gives them the confidence needed to allow them to complete jobs as necessary, whether on the ground or on top of an RV.
